TRANSFORMERS FAULT ANALYSIS - A MULTIDISCIPLINARY APPROACH

Weidmann Electrical Technology AG, Switzerland

Abstract: A large solar plant in Europe has experienced more than twenty transformers failures in less than six months. A multidisciplinary fault analysis was required with the following activities: transformers inspection, on-site measurements, network simulations, transformers manufacturing audit as well as dielectric and water content tests on insulation material taken from failed transformers. The paper describes the multidisciplinary approach utilized for the transformers fault analysis in order to identify the root causes, including those addressable to operations, system integration and transformer manufacturing.

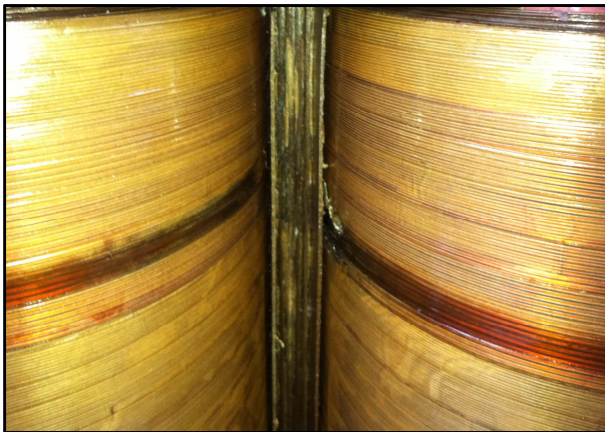
The visual inspection of the faulty five transformers pointed out that all of them showed different degree of damage. In fact, some of them presented only slight puncture signs on the medium voltage (MV) windings while in the others the windings were completely damaged. To be underlined that all the transformers were characterized by the same fault pattern: two-phase passing through the solid inter-phase barriers (see Figure 1). In addition, typical traces of PD in significant quantities were found within the solid inter-phase barriers (see Figure 2).

Figure 1 - Transformers inspection: damaged windings of a SP transformer.

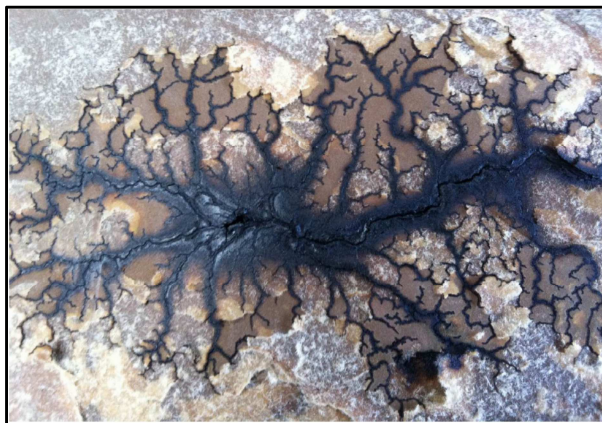
Figure 2 – Heavy partial discharge signs inside an inter-phase barrier.

From the slightly damaged units, it was understood that the dielectric breakdown had its origin inside of the inter-phase barrier, and then spread to the affected windings.

The evident signs of high and diffuse partial discharges in the inter-phase barriers called into question the method of assembly, gluing, impregnation, drying and storage of the materials used.

However, two details of the manufacturing process were noticed to be critical: the application of glue in the assembly of the inter-phase barriers was carried out with too much glue (glue drops on the pressboard giving rise to a possible risk of voids which are not impregnable with oil) and that the drying procedure was not appropriate in order to remove the moisture in the layers of the inter-phase barriers.

Inadequate gluing and insufficient drying processes were deemed to be the main causes behind the failures. Consequently, it was recommended to use less adhesive to glue the paper to the sticks and, at the same time, to

improve the drying process decreasing the water content in the insulating system.

On this regard, a review of the inter-phase barriers design was performed, in order to make more effective the drying process, keeping safe the electrical and mechanical properties required for the same inter-phase barriers.

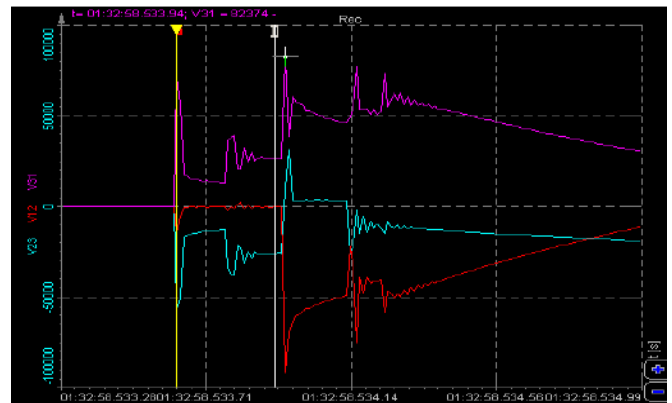
The VCBs openings and closing determines fast front overvoltages due to the restrike or prestrike phenomenon respectively (opening and closing of the VCB). The observed values, relevant to the VCB closing, were 48 kV phase to earth and 91 kV phase to phase (see Figure 4), while for the VCB opening, they were 88 kV phase to earth and 159 kV phase to phase.

The relevant fast front overvoltages (FFO) were repetitive, with severe amplitudes and applied to the transformer terminals each time the CB was operated.

Figure 4 - Recorded fast front overvoltages (phase to phase) during the VCB closing event (about 0.4 ms/div.).

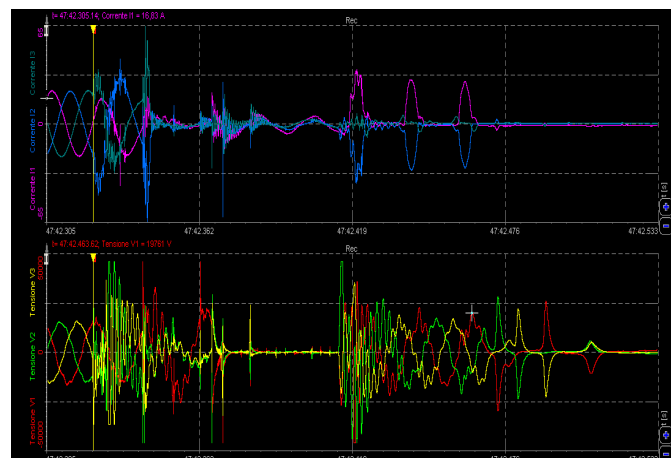
Figure 5 - Currents and voltages recorded during a transformer fault (about 57 ms/div.).

The most severe events were relevant to double phase faults with multiple re-ignitions (these cases refer to the five failures of transformers in service that occurred during the measurement campaign). The maximum slow front overvoltage peak values recorded were of about 62,5 kV (3,2 p.u.) phase to earth and 112,8 kV (3,33 p.u.) phase to phase.

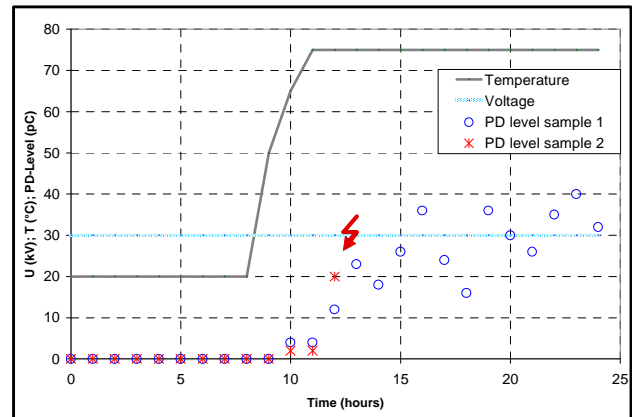
The sample 2 of Figure 9 showed a pattern of traces in the material similar to that one detected in the failed inter-phase barriers, indicating a thermal breakdown due to a very high water content in the pressboard.

The water content showed much too high values (4% to up 7%) for a dried transformer ready to be put into operation.

Figure 9 - Results of test 3. At 23 °C both the samples did not show any PDs, whereas at elevated temperature both samples were affected by PDs. Even worse, test sample 2 had a breakdown after some hours.
