INTEGRATED SERVICES
CASE STUDY
TRANSFORMER FAILURE ANALYSIS

TRANSFORMER FAILURE ANALYSIS CASE STUDY

A photovoltaic plant connected to the HV network has experienced more than 30 transformer failures in less than 6 months. WEIDMANN was engaged to perform five different services:

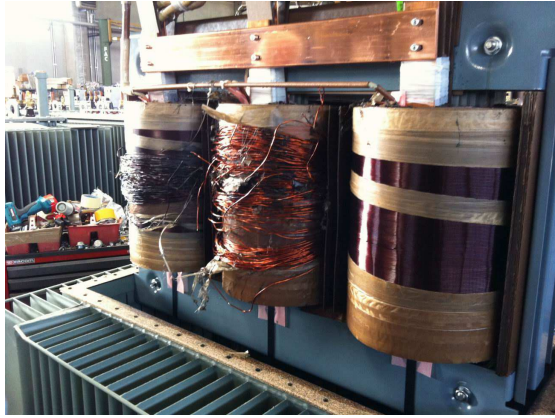
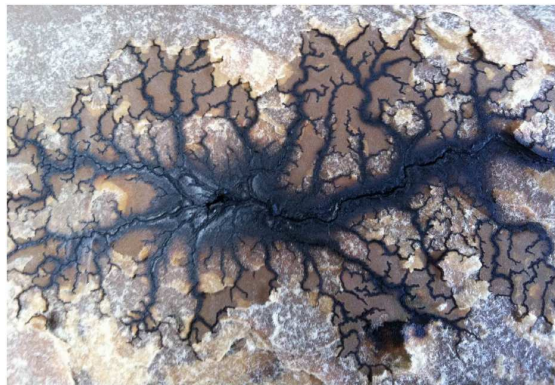
- From the analysed documentation, the transformers withstood very severe tests (PD + Chopped impulse + PD)
- High partial discharges traces on the failed transformers
- All the failed transformers show that the faults occurred between two windings (two-phase fault)
- Always at the same location
- Doubts regarding the method of assembly, gluing, impregnation, drying and storage

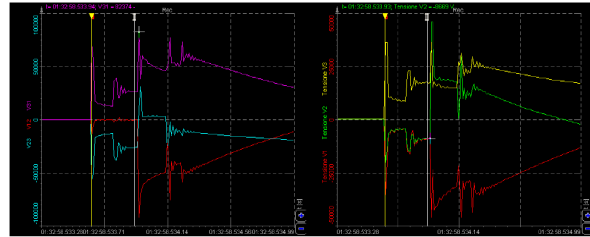
- Vacuum circuit-breaker operations provoke dangerous dielectric stresses, during opening and closing as well

- No other dangerous overvoltages were measured

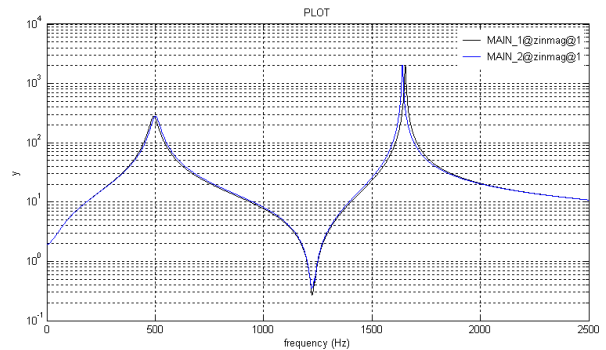
- The electric network configuration gives good performance regarding the overvoltage damping
- Only very unlikely faults (e.g. cutting one conductor after a single-phase fault) can provoke dangerous ferroresonance conditions
- Based on the simulations and measurements carried out, no dangerous slow-front overvoltages were seen

- Based on the above, it strengthens the thesis of a defect in the transformer

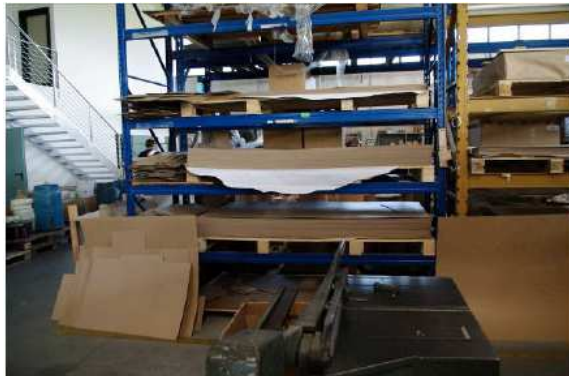
- The assembly of the active parts was clean and properly treated
- The handling of the insulation material in windings and assembly procedure was proper
- Cutting the insulation material and copper in the same machine could lead to contamination of metal particles
- The application of glue in the assembly of the separators should be done by adding as less glue as possible. Glue drops on the pressboard have the risk of voids which are not impregnable with oil

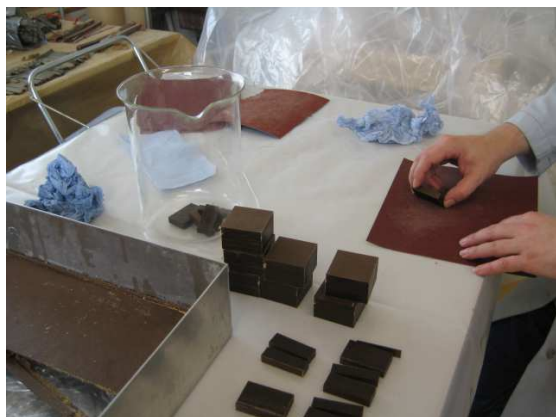
The samples were put between electrodes (Test 1 and 3: glue lines parallel to

equipotential lines; Test 2 perpendicular to equipotential lines)

- It results form dielectric tests that the tested material was of poor dielectric quality
- The water content of the pressboard measured during these investigations (4 to up 7 %) showed too much high values for a dried transformer ready to be put into operation
- Based on the above, review of the transformer manufacturing process was put in place
