InsuLogix® RFM

DEPLOYMENT ON A BANK OF SINGLE PHASE TRANSFORMERS

INSULOGIX® RFM APPLICATION DETAILS

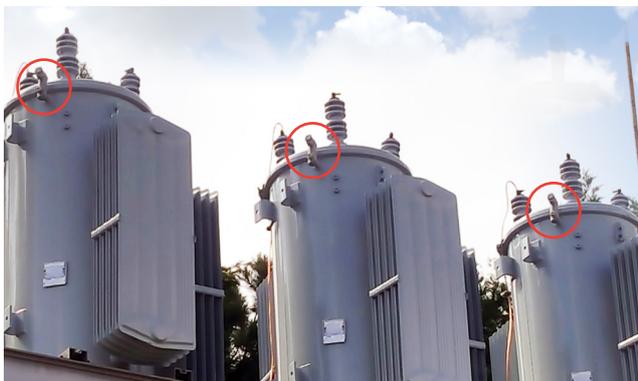
Prior to installing the transformers in their permanent location, the existing pressure relief valves were replaced with InsuLogix® RFMs. All three transformers were installed with individual InsuLogix® RFM devices.

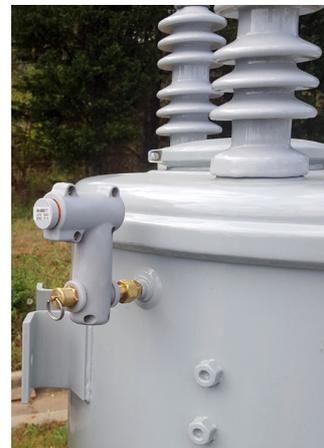
The picture to the left provides a close up of the location of the RFM installed on one of the units.

The main purpose of the RFM is to alert the line-crew that a transformer has experienced an internal fault and should not be reenergized.

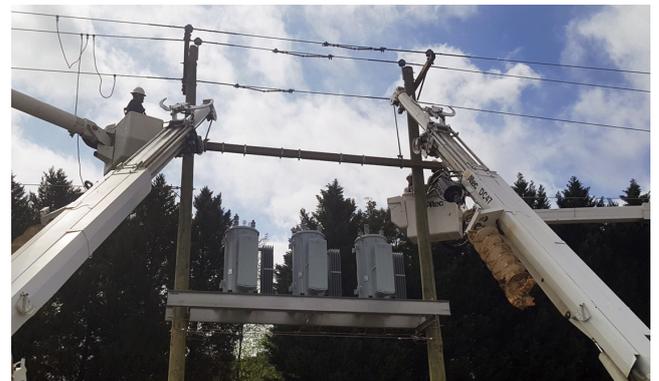
Once the transformers are hoisted into position, the InsuLogix® RFMs are easily visible from the ground providing responding crews with the actionable information they need when responding to an outage to mitigate an unsafe condition created when closing back into a faulted unit.

In the event of a failure, a bright orange flag would be displayed on the tripped RFM, giving a clear and certain indication that a transformer has failed and needs to be replaced prior to re-energization of the circuit.
